Filling and fairing decks

In the second of our series on restoring a bargain £900 Quarter-Tonner, Rupert Holmes shows how to strip, fill and fair GRP-covered plywood decks

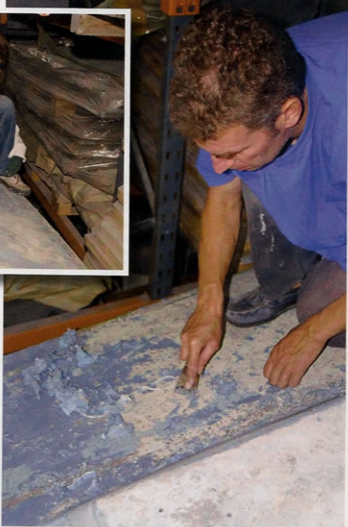
ABOVE and RIGHT Stripping the deck paint using the chemical stripper proved frustratingly slow

There appeared to be only two other options at this stage – using a chemical paint remover, or a hot-air paint stripping gun. The hot-air gun needs great care if used on a glassfibre surface, as it can melt the laminate just as effectively as the paint, so I opted for the chemical stripper.

Some research online found a suitable product from Ecosolutions that can be bought mail order, or from B&Q. As well as being safe for use on glassfibre, it's also water-based, and a lot more pleasant to use than conventional paint strippers.

All the same, using it proved to be painfully slow and, worse still,

the fairing compound came off with the paint! It seemed, though, that I had no choice but to persevere with this route, although I still used a hot-air gun with extreme care to finish off any particularly stubborn areas.
